Inspection Report
Minerals Regulatory Program
June 3, 2008

Mine Name: Cloudy Moon
Operator Name: Moon Mountain Stone

Permit number: S0370116
Inspection Date: April 29, 2008
Time: 9:50-10:10

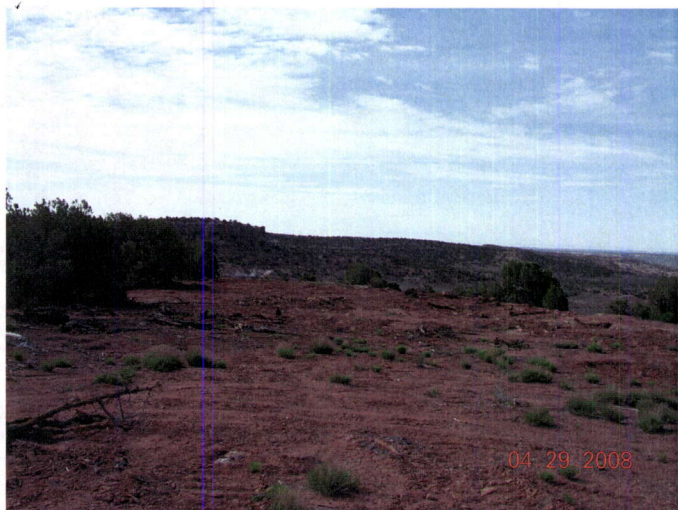
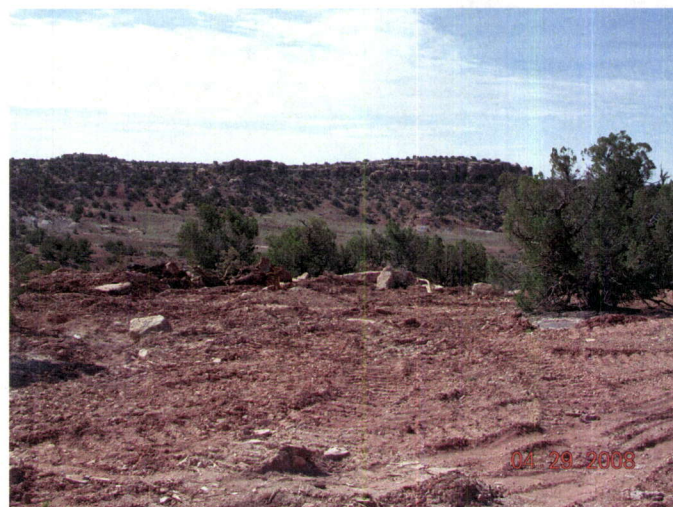
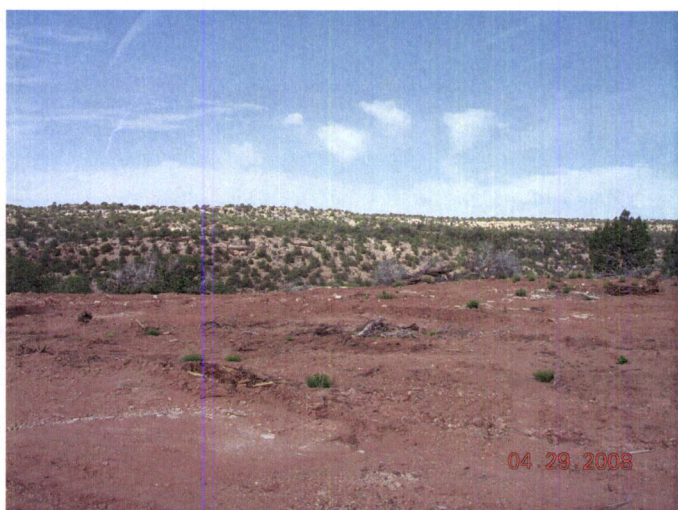
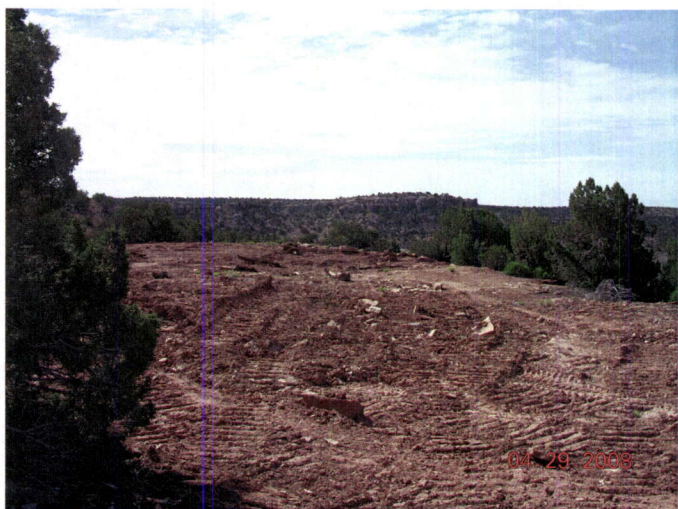
There was not a lot of regrading to do, but the operator's contractor has completed the grading and did a good job. The site was moderately rough, and the contractor spread juniper slash around. I found seed but no seedlings.

Photo 1. These four photos show various views of the site, including both the west and east quarries.

Violation MN2007-03-09 has been abated and can be terminated. The Division and the operator will need to monitor the site for revegetation success.
